Kamil TITZ, Kateřina KONEČNÁ, Miroslav TVRDÝ¹

SURFACE SPOTS ON PLATE OF ALUMINIUM ALLOY

¹ *Metallurgical and Material Engineering Faculty, VŠB – TU Ostrava, Czech Republic*

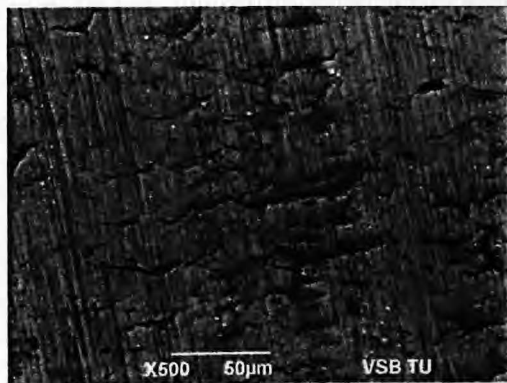
The photographs from the surface of samples No. 1 to 3 are shown in the Figs. 1 to 3. As shown at the samples 1 – 2, in place of the surface spots we see the microcrack network, which represent the not sufficient deformability of surface layers. On the third sample (reference specimen) it is only the surface roughness which is evident in the Fig. 3. The surface is relatively smooth and some microcracks evident on the surface are only of very small dimensions and are not disturbing the integrity of surface.

Fig. 1 Surface cracks in sample No. 1

The surface spots visible on the samples 1 and 2, taken from the apparently defective plate, are caused by the occurrence of microcrack network in the surface area. Such microcrack network is possibly of metallurgical character and has no correspondence to the surface of tools (rolls). In further dealing with the problem it would be necessary to take in the account the origin material and the metallurgical technology of its preparation. The surface chemical analysis has not brought us the required result. In case of industrial atmosphere around the aluminium plate with such spots there is the danger of the initiation and further crack growth from such spots /1/.

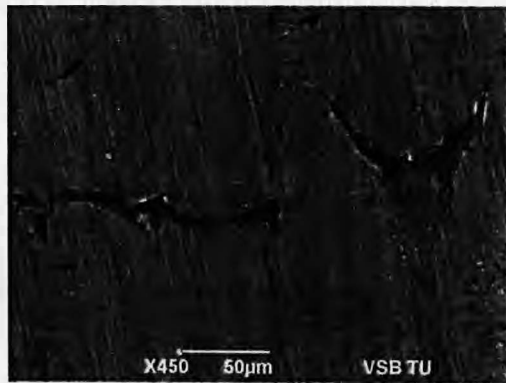
Fig. 2 Microcrack network in sample No. 2

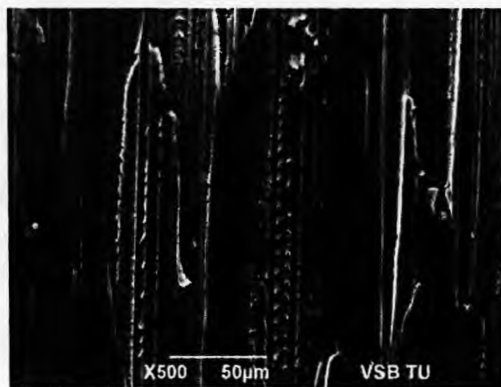
Fig. 3 Smooth surface of sample No.3

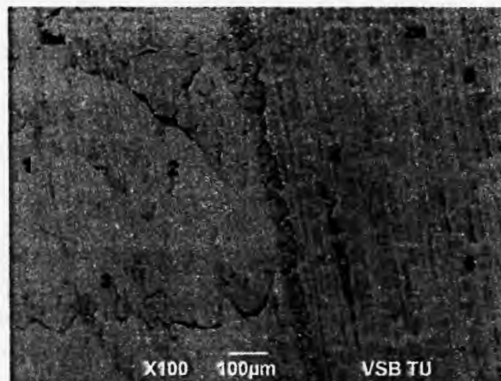
The surface chemical analysis is shown in the Figs. 4 and 5 (for the samples 1 and 2) and in the Fig. 6 for the reference sample 3. On the basis of the detailed chemical analysis it is not possible to decide about the spot origin.

Fig. 4 Spot where the local chemical analysis has been taken

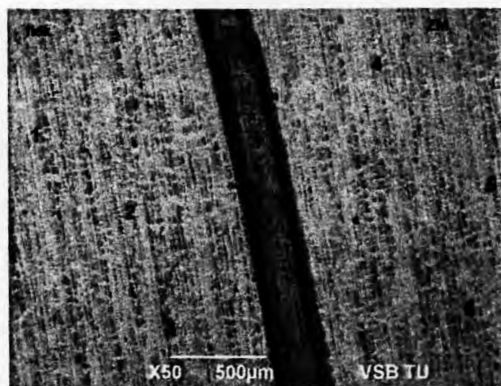
Fig. 5 Spot where the chemical analysis has been taken

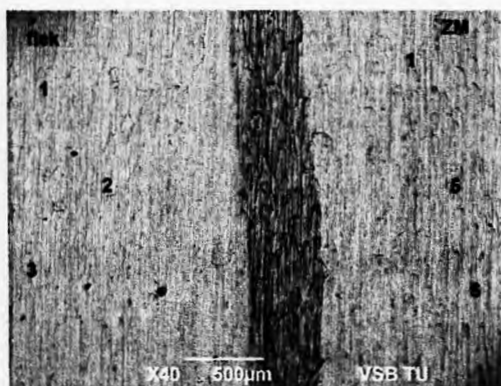
Fig. 6 Spot where the chemical analysis has been taken
